TECHNICAL NOTE

Split peaks as a phenomenon in liquid chromatography

TN 10 000 001 BA

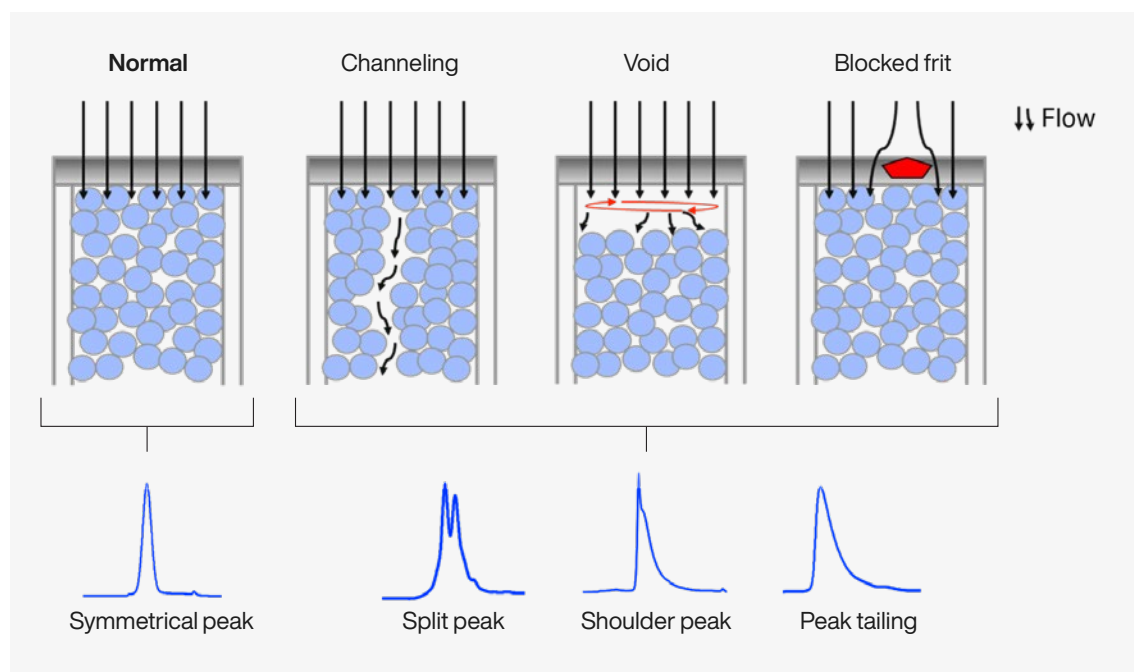
Common causes for peak-splitting, distorted peaks and peak tailing are non-optimal packing of the resin which can result in channeling or a void at the top of the packed bed (Fig. 1). Another cause relating to the column hardware can be partially blocked flow path or clogging of inlet filter/frit (Fig. 1). Some resin properties, such as unspecific hydrophobicity has been shown to promote peak-splitting under certain conditions of some molecules. Lastly, the target itself may be the cause of peak splitting due to aggregation or charge differences, for example. A good rule of thumb is if only one peak is splitting, then the issue is most likely method or chemistry related, *i.e.* not due to packing or hardware defects. Changing the injected mass of sample to study ratio of split peaks/distorted peaks can also indicate if it is one or two partially resolved compounds.

- A bed packed too densely might crack, which can lead to channelling and early breakthrough. If some of the target molecules diffuse in the cracks and others in the beads it might result in split peaks.

- A bed packed too loosely can further compress causing a liquid gap, a void at the top of the column where mixing can occur. This induced mixing chamber will generate an uneven diffusion of the target molecule into the resin resulting in less defined peaks.

- The frit and/or spreader in the top adaptor of the column protects the resin from large contaminants and provides an even spread of the loaded sample onto the resin. A clogged or damaged frit/spreader will affect the uniformity of the sample spreading. If the clogged frit is due to target aggregation for example, it may partially release from the frit over time which will also distort the peaks and may lead to split peaks. Dead volumes (cavities) in the system flow path (such as mixer/t-connections) may also negatively affect the separation of the molecules.

Figure 1. Peak splitting or distorted peaks depending on resin integrity or hardware issues.

Running a purification in reverse mode and studying the elution profile may tell you if the resin integrity is compromised (void or channeling) or if there is clogging in the frit in the top adaptor since these issues appears in the top part of the column. The resin can also be cleaned operating in reverse flow to efficiently clean the frit and upper part of the column. The wash buffer may include organic solvents such as acetonitrile or methanol to remove hydrophobic contaminants, check the resin's specifications. If the resin integrity is poor, it can simply be repacked, and split peaks may be diminished.

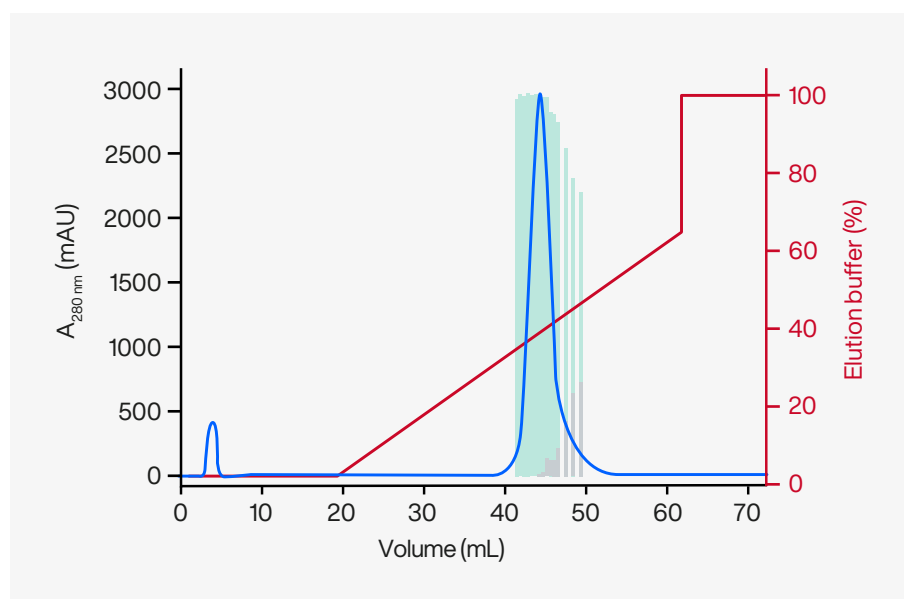
It has been reported that the proportion of on-column aggregate formation partly depends on the resin pore sizes, pore size distributions, different surface extenders and also interactions between the mAbs and the resin's structure (Guo and Carta 2015, Guo et al. 2016, Reck et al. 2017). WorkBeads™ 40S shows a very low proportion of on-site mAb aggregation (Fig. 2).

Figure 2. mAb polishing on WorkBeads 40S. Main peak consists of monomers (green bars) and aggregates (grey bars). Since there is a partial overlap between monomers and formed aggregates, the peak is partially distorted. After removal of aggregates the peak consists of <1% HMWS and is symmetrical.
